USAARL REPORT NO. 84-1

**UH-60 SHOULDER HARNESS LEAD-IN  
STRAP FAILURE ANALYSIS**

**BIODYNAMICS RESEARCH DIVISION**

**October 1983**

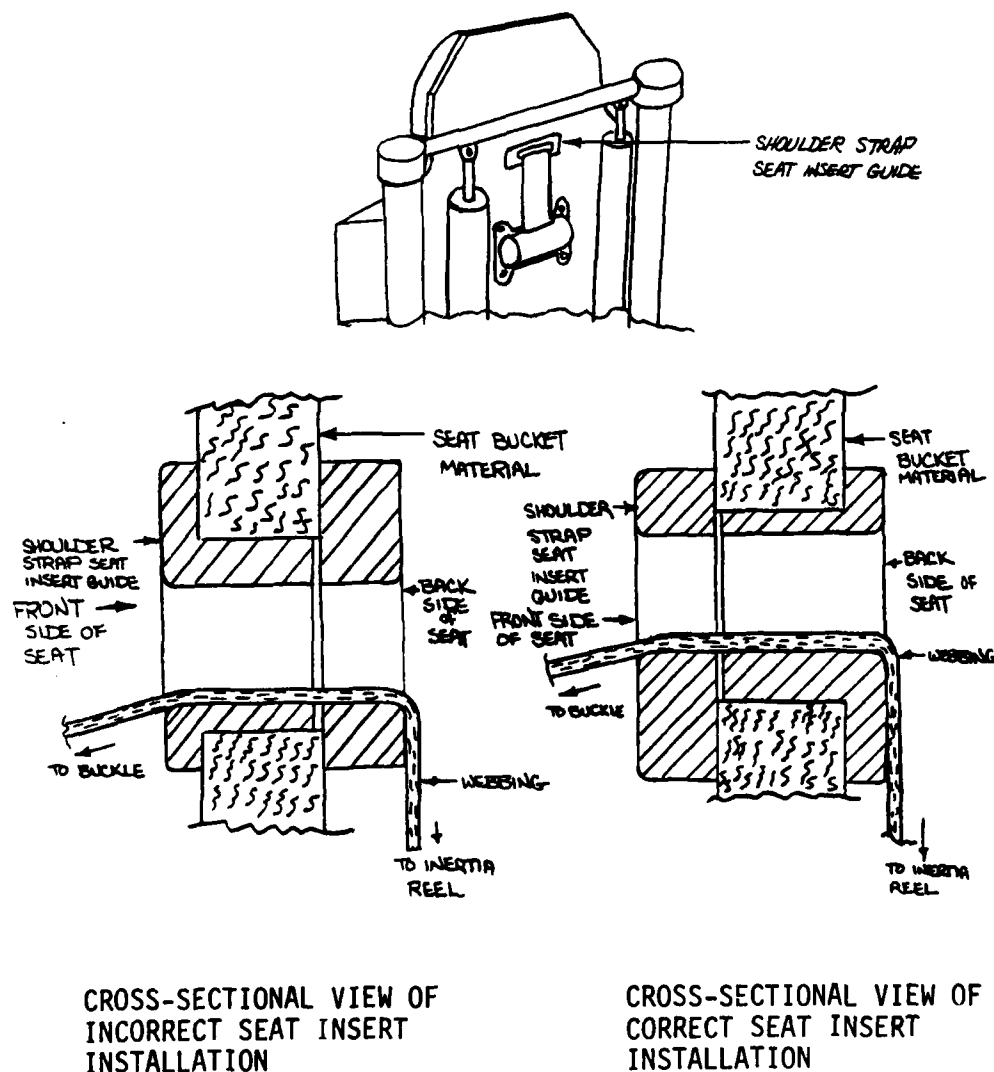
Figure 2. Illustration of Correct and Incorrect Installation of Seat Insert Guide.

Two potential causes for the failures were identified. The first was improperly installed lead-in strap seat insert guides. In the first two lead-in strap failures, the insert guides were installed reversed and upside down (Figure 2). In this orientation, the lead-in strap loads deformed the lower rear half of the guide and exposed a sharp edge to the strap. This may have caused a stress concentration or may have cut the strap resulting in a failure at a lower-than-designed load. The guides have since been removed and reinstalled correctly.

In the first series, the pure tension failure loads for the Murdock X-854 webbing were 6,740 pounds and 7,080 pounds, an average of 6,910 pounds. Loads were applied at the rate of 10 inches per minute. The failure loads for the longitudinal loading using a seat insert guide installed upside down and reversed were 3,320 pounds and 3,010 pounds, an average of 3,165 pounds. That is a 54 percent reduction in average breaking strength when compared to the pure tensile load test. The failure load for the one combined lateral-longitudinal loading test was 2,960 pounds, a 57 percent reduction in breaking relative to that of the pure tensile breaking strength.

In all cases a significant reduction in tensile strength was shown when the webbing was forced to change directions by bending over the seat insert guide. The greatest reductions in failure loads were caused by the combined lateral-longitudinal loading and by the incorrect installation of the seat insert guide. The seat insert guide installation problem has been corrected, but the combined lateral-longitudinal loading problem remains as a potential threat.

The conclusion of this investigation is that the shoulder harness restraint systems failed at lower than expected loads because of the combination of the incorrect installation of the seat insert guide and the stress concentration caused by the bending of the webbing as it comes up the back of the seat and through the seat insert guide. As a result of the communication of the early findings of this author to the manufacturer, the incorrect installation of the seat insert guides has been corrected. Further research into the effect of bending radius on webbing stress concentration is, however, recommended.

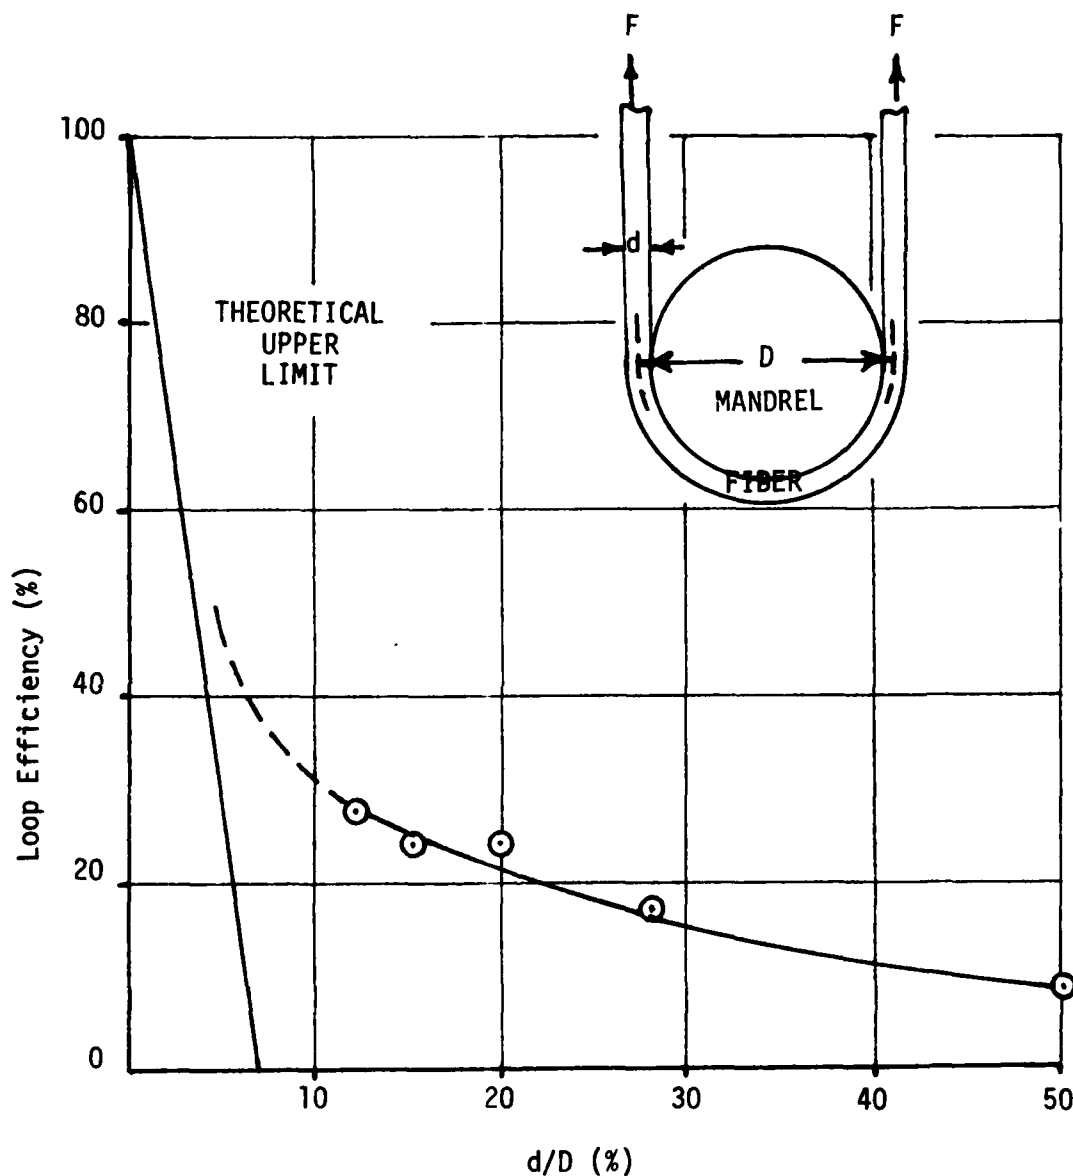
Figure 6. Single Fiber Loop Efficiency for High Tenacity Polyester Fiber (Figure redrawn from Bending limits of some high-modulus fibers, *Textile Research Journal*, Vol. 44, No. 12, Dec 1974, p. 972).

An article found in the *Textile Research Journal* (Schoppee and Skelton, 1974) dealt with the effect of bend radius on the tensile failure strength of individual fibers. Although the article's authors' findings cannot be directly applied to woven webbing, the results found for individual fibers may suggest a trend that also will be found in woven webbing. In particular, they presented a curve showing that high tenacity polyester fiber, which is the material used in the restraint harness webbings addressed herein, is sensitive to the radius of curvature around which it is bent. Their data (Figure 6)

show that the breaking strength of the fiber is reduced by approximately 30 percent when pulled around a cylinder with a diameter no more than 10 times the diameter of the fiber. As the diameter of the cylinder gets smaller, the breaking strength of the fiber continues to decrease. When the ratio of the diameter of the fiber to the diameter of the cylinder approaches 1/20 (i.e., 5 percent), the breaking strength is reduced by 50 percent.
